HP Latex 3XX and 5x0 Series Printers

TECHNICAL NEWSLETTERS FROM CUSTOMER ASSURANCE

Date: September 2019

Telescoping, Media Skew, and Media Advance correction

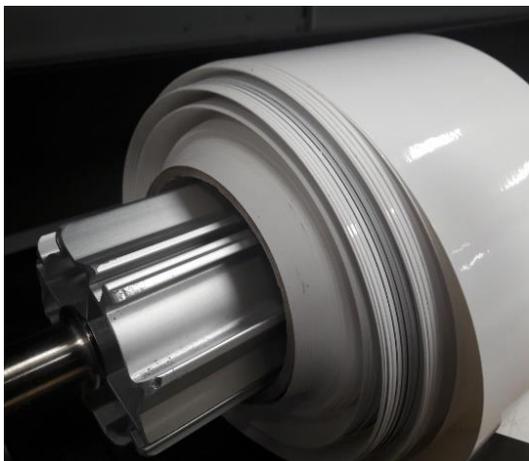
Telescoping can be described as lateral movement or sliding of the media along the media core during winding. This lateral movement causes the media to wind off-center in a progressively misaligned manner, potentially forcing the media into the spindle hubs at either end. Any hub contact can cause rippling or damage to the media edges, and in extreme cases cause printhead crashes due to waves in the print media before the output platen.

Media telescoping on TUR

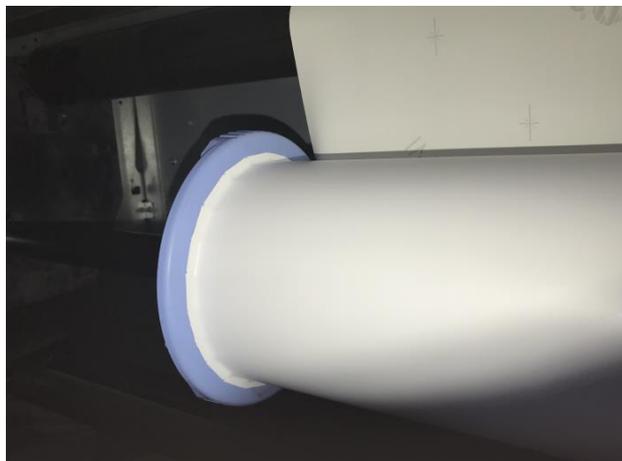
Media-to-Hub contact

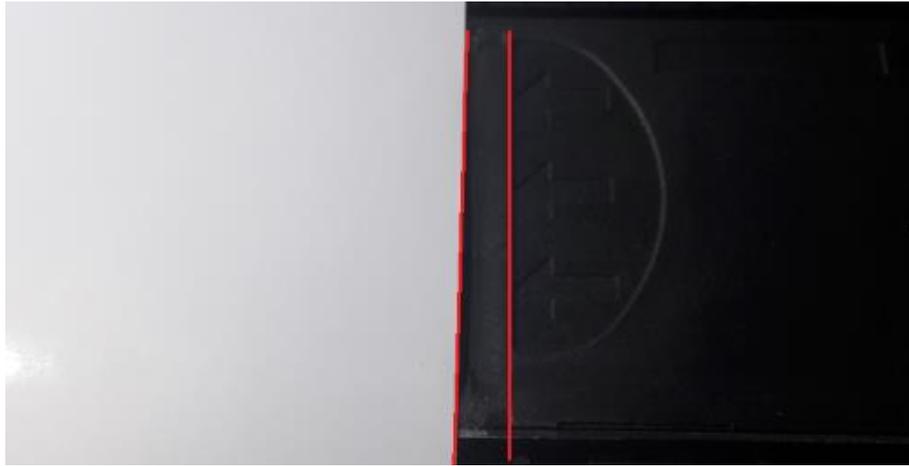
Media skew can be defined as the abnormal traversing of the media when moving through the print zone, or the media not advancing parallel with the vacuum platen. Excessive media skew can lead to image quality issues and media advancement issues, leading to:

Media not moving parallel through print zone

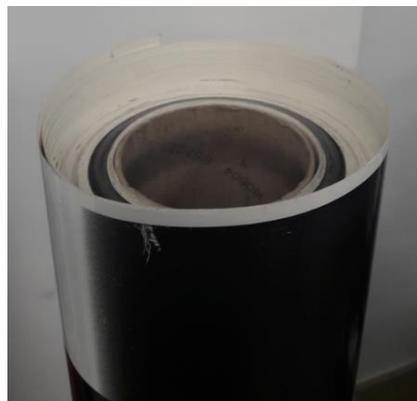
Telescoping from lifting

- Keep the media in the same room as the printer for at least 24 hours (for media susceptible to shrinkage). A difference in temperature between media and printer can cause distortion during curing.
- Ensure the media is loaded correctly onto the core with straight edges, and that the media is wound tightly. Cheaper media can often be wound at the incorrect tension, which can leave excess air between the layers. Media can also be wound at different tensions at both ends, which can be identified by a loss of tension at one side of the substrate between the input roll and the drive roller.
- Do not lift the media roll vertically from the center (axis of core facing up), especially with low friction media, as this can cause the media to telescope and lose tension.

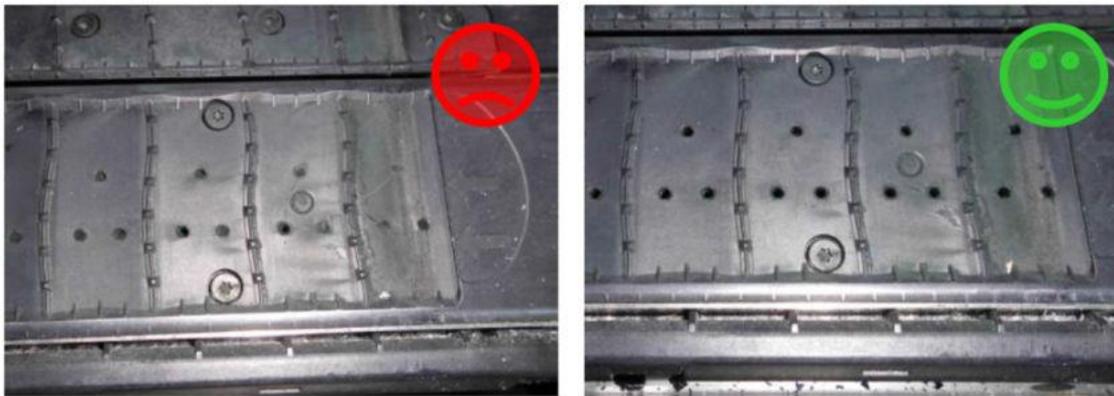
Blocked vacuum holes

- Verify that the maintenance schedule been kept and the correct maintenance has been performed.
- Check that the firmware is up to date, as the latest versions of the firmware can correct communication errors, or provide new correction options from the front panel or RIP.
- All vacuum holes on the platen should be free of dust, debris, and ink to prevent uneven vacuum across the platen (please refer to the User Guide for the full vacuum cleaning process). Blocked holes can cause the media to move on the platen at different rates depending on the vacuum applied. If the TUR is in use, try to lower the vacuum level

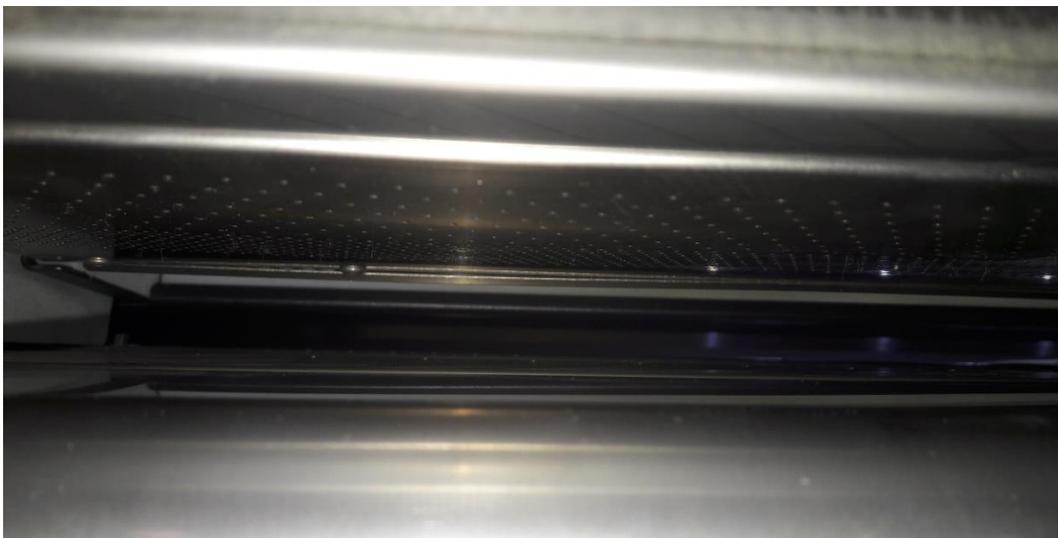
Impinging air curtain exit holes

- Verify the impinging module air curtain exit holes are clean and that uniform heat is being delivered to the print area. Uneven curing can lead to media distortion through the output platen.

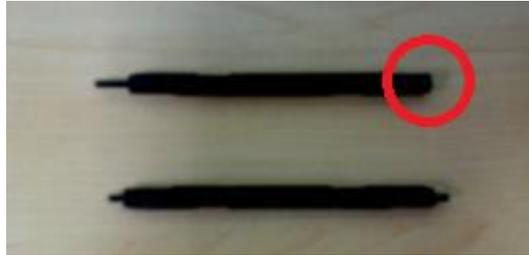
Broken Pinch Wheel

- To promote smooth media advancement, the drive roller should be clean and debris-free, and the pinch wheels should be able to move freely. Replace any pinch wheels if they are broken or cannot move freely.

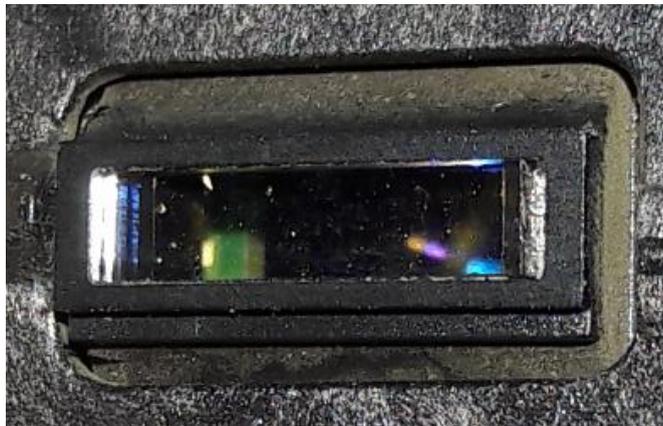
OMAS with particles under glass

- Ensure the OMAS sensor is kept clean. The OMAS may need to be cleaned thoroughly or replaced if the window is permanently obscured. If the media is suspected to not be read by the OMAS, try disabling the OMAS in the printer's front panel.

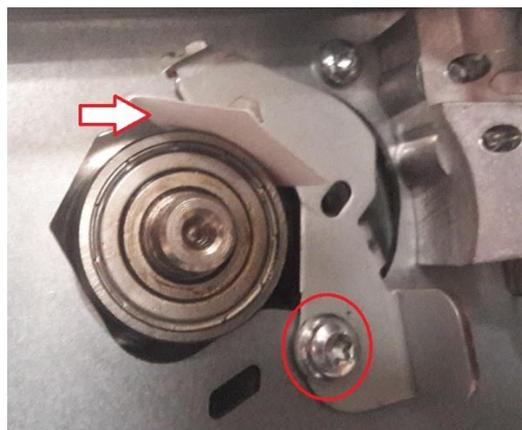
Drive roller gap

- Perform diagnostic tests on the rewinder system, drive roller, substrate path sensor, and auto pinches under **Diagnostics checks > Substrate path**.
Note: The auto pinches test is not applicable to 3XX series printers.
- Remove right cover and service station and check drive roller brake/bracket. Check to see if there is a gap between the driver roller and the roller brake/bracket. This can be performed by using a slip gauge or sheet of paper (approx. 100g weight). If a gap is identified, loosen the highlighted screw, move the bracket tight to the drive roller, and re-tighten the screw. Perform the drive roller calibration if the position of the bracket was adjusted.
