# PASSPORT

## Service Bulletin

8/27/2007

### Trouble Shooting Overspray

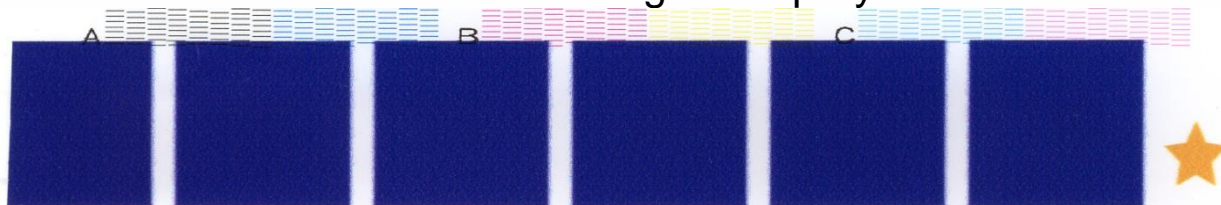
Overspray, also known as misting, can be caused by a variety of reasons. In the sample print notice the slight haze around the edge of the blue blocks, this is the overspray. Also check the platen and all around the inside of the machine near the print area. If there is a haze present or the machine has a fine misted ink that has settled on the interior there is an issue with overspray.

1. Perform a test print (nozzle check) Is nozzle deflection present? Large nozzle deflection can cause overspray.
2. Look at test prints to determine which print heads are giving the overspray. Use a loop to get the detail you will need. How many print heads are seeing the overspray? Best to check along the straight edge of a vector based graphic for optimum sharpness. Print a thin black line if needed. Black uses all colors when printed so overspray should show with this test. Use this to determine which print heads you will focus on. Always perform test prints from Versaworks to insure accurate results

3. Print a service report and check the shot counts for any overages; do the overages correspond to the heads which are giving overspray? If so these print heads could have reached the end of their life cycle. Print heads that are damaged from head strikes will overspray due to nozzle deflection so be sure to make end users aware of this issue since head strikes are not covered under warranty.

4. Check the head height setting. Improper head height can cause overspray.
5. Check media type, some 3rd party media have a polyester liner which can cause static build up, use Roland Media for testing purposes to insure accuracy.

6. Check all print head alignments and calibrations. A head crash can throw a print head off dramatically
