White Ink Dripping from Printhead Nozzles

When the ink system vacuum can no longer hold up the ink, it will drip.

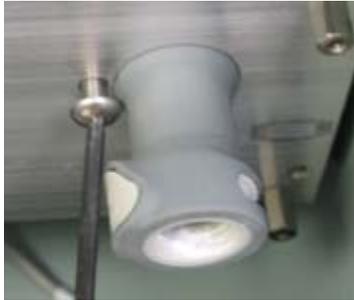
Previous Gray Coupler

-
- a) The male portion of the twist lock has only two tabs that act as its threads and over-tightening can easily bend these tabs. Bent tabs prevent adequate seal of the connection allowing air to enter the system.
 - b) If the luer barbs are not perfectly round or if they have small nicks or scratches, air can enter into the system. This is more of a problem with barbs on the single walled tubing, as the tubing does not fit as well around the bard.
- 5) Air in an ink bag.
 - 6) When removing an ink bag, a small amount of air can enter the ink system as the ink coupler closes. Make sure the ink coupler (3010109812) is the newer (blue) version shown below as it traps the air more effectively. This new coupler was included in the Mandatory White Ink Recirculation Valve Upgrade Kit (See Modification Bulletin 21C).
